# National Transportation Safety Board

## Marine Accident Brief

### Allision of Tanker *Aframax River* with Mooring Dolphins, and Subsequent Fire in Waterway

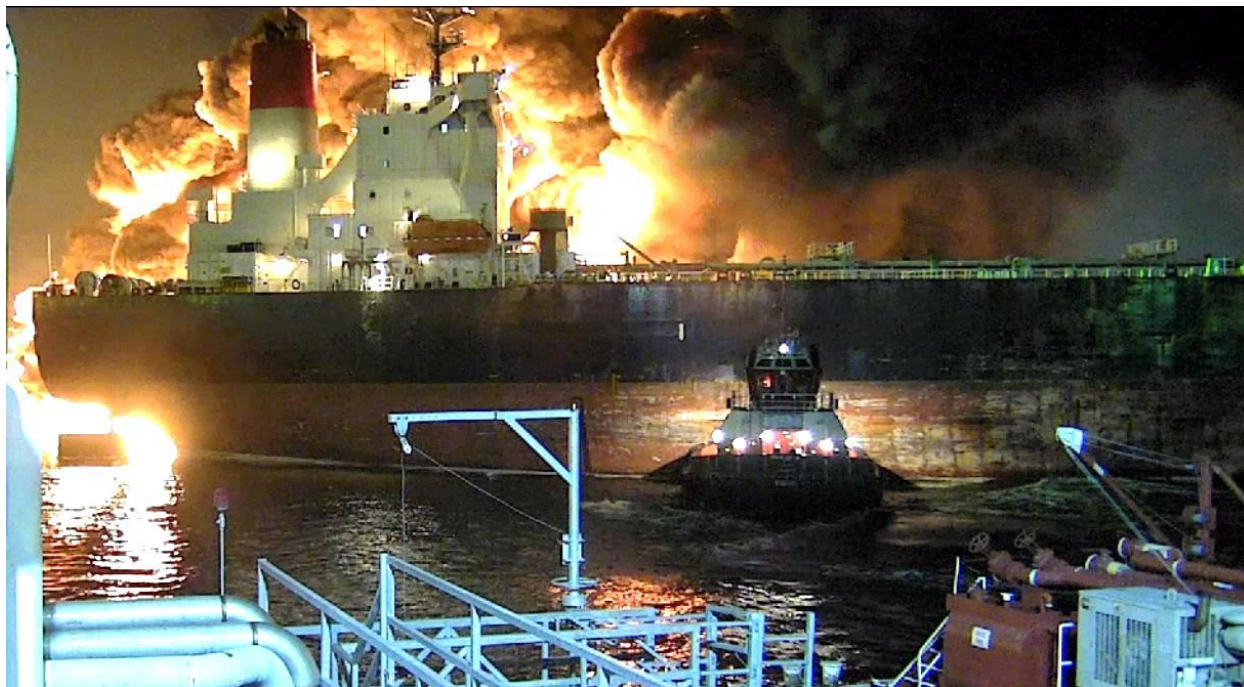
When an allision with the mooring dolphins was imminent, the master ordered the deck crew to stand clear of the stern of the vessel and brace for impact. At 0005, the port side of the *Aframax River* struck the first ITC dolphin, no. 78A, at 3.2 knots. Within seconds of that impact, the tanker's port quarter struck the second ITC dolphin, no. 78B. The second allision tore an approximately 30-foot-long opening on the ship's port quarter hull plating at frame 26, about 8 feet above the waterline near the centerline of the no. 2 fuel oil tank. Marine gas oil (MGO) immediately began pouring out of the hull opening. As the tanker continued aft, its hull plating was further cut and deformed inward by contact with the mooring dolphins. The friction and the cutting of the hull plating generated heat, which ignited the MGO and triggered a large fire with thick, black, bellowing smoke that engulfed the ship's port quarter and the adjacent main deck, all the way up and past the port bridge wing. The general alarm was sounded.

***Aframax River* after the allision with dolphin no. 78B. Tractor tugboat *David B* is in the foreground rendering assistance. (Image courtesy of ITC City Dock security video)**

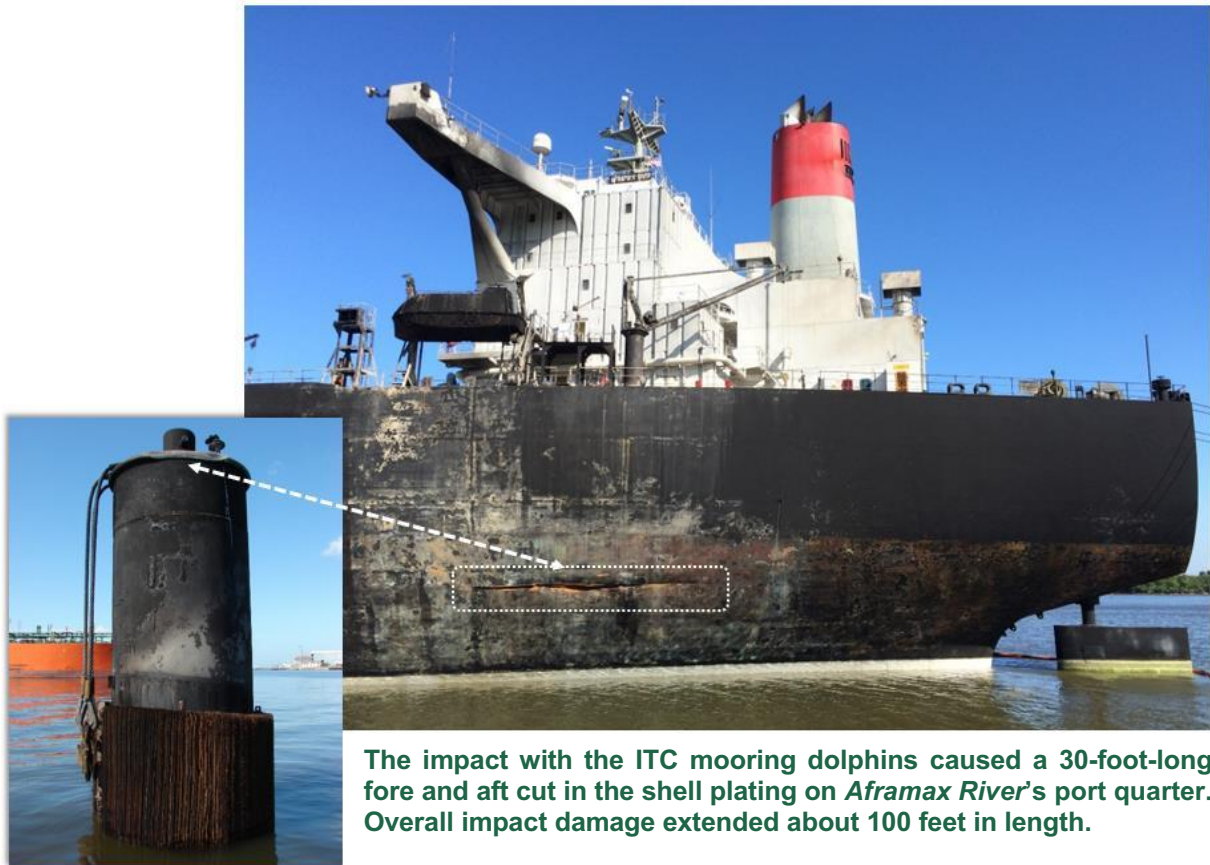
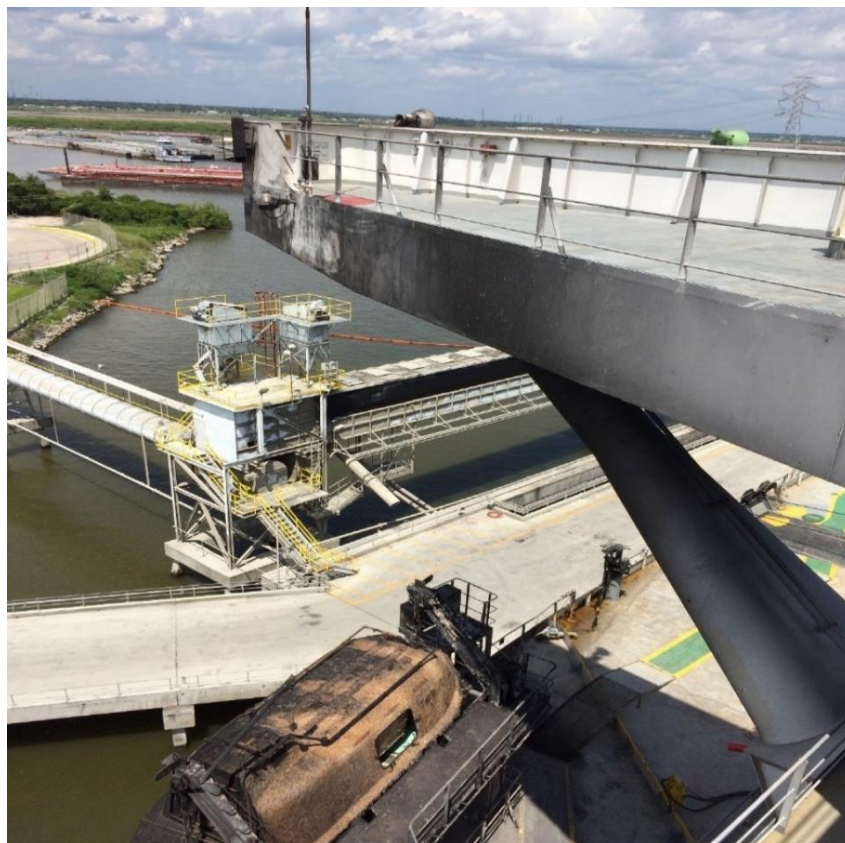
The *Aframax River* crew conducted soundings on all of the tanks to determine the extent of damage to the hull. As a result of the breach in the no. 2 fuel oil tank, about 88,000 gallons of MGO spilled into the waterway. The fire severely damaged the portside lifeboat and davit system, two liferafts, the port crane at frame 27, and an embarkation ladder. Damage extended about 100 feet along the portside hull between frames 24 and 41. Several of the tugboats involved in the response effort also sustained damage to their equipment.

Fire damage to *Aframax River*'s portside bridge wing (where the conning pilot was standing when the fire erupted), lifeboat, and main deck.

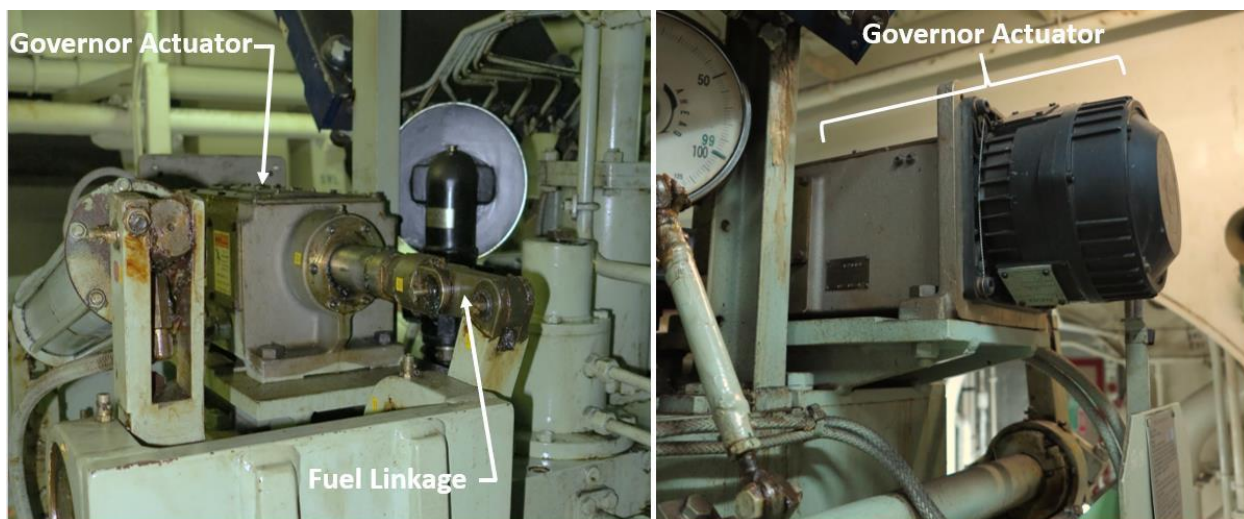
The Diesel United - Sulzer Type 7RTAC2 is a single-acting, slow-speed, two-stroke, reversible marine diesel engine. The engine was directly connected to the propeller, and the engine was designed to come to a complete stop when changing propeller direction from astern to ahead. In the presence of investigators and ClassNK surveyors, technicians from Diesel United, Ltd. inspected and tested the mechanical components of the governor input, fuel control linkage, and other related components. All items were determined to be in good working order.

**Front and back of the main engine governor actuator and mechanical fuel linkage.**

According to the manufacturer's technicians, the governor's actuator system experienced a momentary abnormality. Investigators believe that the abnormality likely resulted from an electrical and/or mechanical failure of the system, which led to loss of engine control while the vessel was engaged in astern propulsion.

The National Transportation Safety Board determines that the probable cause of the *Aframax River*'s allision with mooring dolphins and the subsequent fire in the waterway was a momentary abnormality of the tanker's main engine governor actuator system in responding to command inputs from the bridge.
